# REKONŠTRUKCIA BRATISLAVSKÉHO TUNELA Č. 2 RECONSTRUCTION OF THE BRATISLAVA TUNNEL NO. 2

The aim of the article is to present the extent of the reconstruction works in the Bratislava tunnel no. 2 and the used technology. The line Devínska Nová Ves – Štúrovo is located on IV. corridor and it is a connection between Vienna and Prague via Bratislava to Budapest, while the Bratislava tunnels no. 1 and 2 run through the Malé Karpaty massif. Bratislava tunnel no. 2 construction started on December 15, 1900 and was completed in 1902. On the south side, it is adjacent to the historic Bratislava Tunnel No. 1, which is the oldest railway tunnel not only in Slovakia, but also in the entire former Austro – Hungarian Empire. Both tunnels and their portals are part of a complex registered as a National Cultural Monument of the Slovak Republic. The company TuCon, a. s. started reconstruction work in tunnel no. 2 in August 2022. Since the tunnel was part of existing railway infrastructure, the work had to be carried out in time periods during which the railway operations were interrupted. In addition to the rehabilitation of the tunnel's stone masonry lining, the installation of a new electric tr

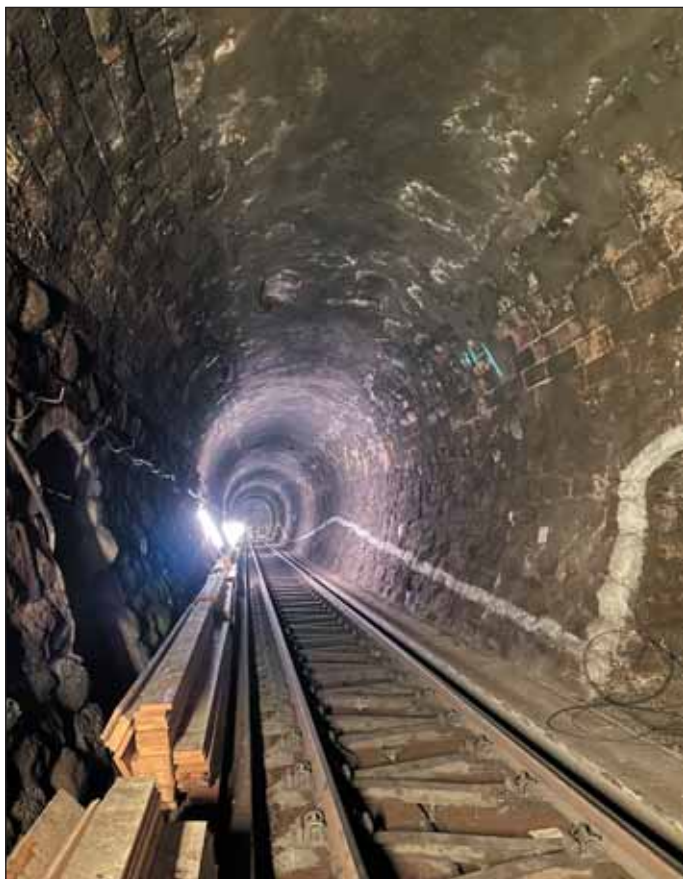
Obr. 2 Stav Bratislavského tunela č. 2 pred rekonštrukciou  
Fig. 2 Condition of the Bratislava tunnel no. 2 before reconstruction

The structure is located in the geological environment of the Malé Karpaty mountain range. The overburden of the tunnel contains marly shale, layers of kaolin and scattered harder rocks such as granite or pegmatite. Due to the significantly disturbed overburden, water occurs almost along the entire length of the tunnel. That's why the original drainage solution provided for waterproofing of asphalt strips and longitudinal drainage, supplemented by vertical culverts, 20 × 20cm, behind the lining. Due to persistent leaks, several construction modifications were carried out in the tunnel no. 2, in the past. In 1966, as part of the preparations for the electrification of the Devínska Nová Ves – Štúrovo line, shotcrete with an average thickness of 100 mm, anchored to a steel mesh, was applied to the tunnel vault along its entire length. As part of the reconstruction of tunnel no. 2 in 2008, a slab trackway with a railway was built, as well as a new central drain Ø 250mm with side drains, in the distance of 160mm from the lining. Despite these measures, water seepage through the stone masonry lining (especially in the tunnel vault) increased over time, which led to peeling of the old shotcrete coating (Fig. 2), to falling of water-saturated stone blocks or to the leaching of cement material from the lining joints, which threatened the safety of the passengers and the continuity of railway service. Likewise, the components of the railway superstructure and the traction were damaged due to moisture and regular flooding, and icing in the winter, which had a negative impact on their service life and thus increased the financial costs of routine maintenance.

počítalo s rubovou izoláciou z asfaltových pásov a pozdĺžnou drenážou, doplnenou o zvislé zvodnice za ostiením s rozmerom  $20 \times 20$  cm. Z dôvodu pretrvávajúcich priesakov boli v minulosti v tuneli č. 2 vykonané viaceré stavebné úpravy. V roku 1966, v rámci príprav elektrifikácie trate Devínska Nová Ves – Štúrovo, bol v klenbe tunela na celú jeho dĺžku aplikovaný striekaný betón v priemernej hrúbke 100 mm, kotvený na oceľovú sieťovinu. V rámci rekonštrukcie tunela č. 2 v roku 2008 bola vybudovaná pevná jazdná dráha so železničným zvrškom a tiež nová stredová stoka Ø 250 mm s bočnými drenážami Ø 160 mm pred lícom ostenia. Napriek týmto opatreniam sa priesaky vody cez kamenné ostenie (najmä v klenbovej časti tunela) v čase zvyšovali, čo viedlo k odlupovaniu starého torkrétového nástreku (obr. 2), k vypadániu vodou nasýtených kamenných kvádrov či k vyplavovaniu cementového materiálu zo styčných škár ostenia, čo ohrozovalo bezpečnosť cestujúcej verejnosti a plynulosť železničnej prevádzky. Rovnako sa vplyvom vlhkosti a pravidelným zatápaním, v zimnom období zaľadnením, poškodzovali komponenty železničného zvršku a trakčného vedenia, čo malo negatívny dopad na ich životnosť a navyšovali sa tak finančné náklady na bežnú údržbu.

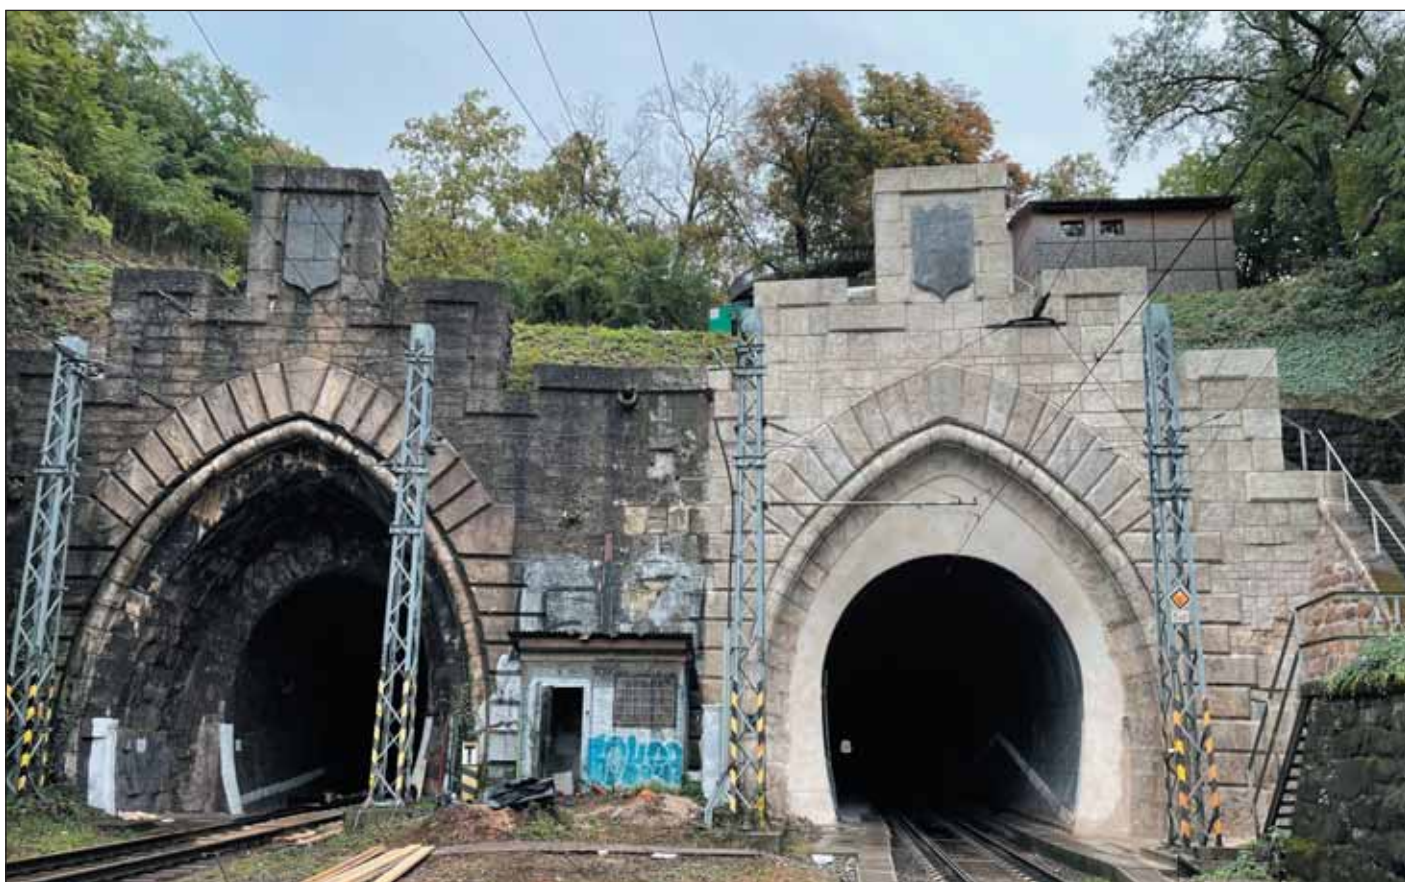
Obr. 3 Obnovená plocha portálu P1 v okolí Bratislavského tunela č. 1 po výluke N1

Fig. 3 Renewed area of portal P1 in the vicinity of Bratislava tunnel no. 1 after the N1 closure period

Injection drillholes had a diameter of 10mm and a length of 450mm. The horizontal spacing of the drillholes was approx. 0.66m, the vertical spacing always depended on the actual position of the given stone masonry joint. After finishing the chemical grouting, the surface of the brickwork was handcleaned and retouched with a lacquer coating. As the construction was approaching the winter period, the completion of the restoration work was moved to the N3 closure period planned in the warmer season. In total, during this period, it was possible to restore areas with an area of 424.4m<sup>2</sup>. The renewed area of portal P1 in the vicinity of Bratislava tunnel no. 1 is shown in Fig. 3.

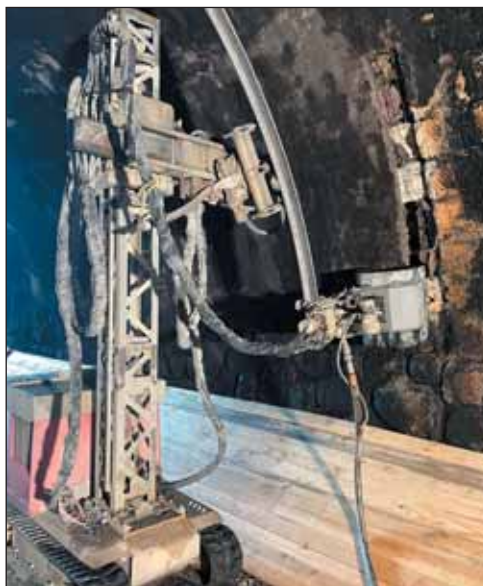
Obr. 4 Odstránenie starého torkrétového nástreku z ostenia tunela hydrodemolačným robotom Aquacutter 710 V  
Fig. 4 Removal of old shotcrete from the tunnel lining with the hydrodemolition robot Aquacutter 710V

Construction and assembly work in tunnel no. 2 started at the end of September 2022 during the N2 closure period that lasted 231 days. The work began with the dismantling of the original traction current line, lighting distribution cables and security equipment. After dismantling, the entire length of the tunnel was protected with wood and geotextiles against pollution and damage. A total of 165m<sup>3</sup> of spruce lumber was used. Subsequently, the old shotcrete could be removed from the tunnel vault. For this activity, the hydrodemolition robot Aquacutter 710V with a high-pressure pump was used, which can develop a water jet with a pressure of up to 4000 bars (Fig. 4).

The advantage of deploying this robot was that simultaneously with hydrodemolition, the process of removing loose parts of the tunnel lining, as well as the process of deep grouting, could take place by simply adjusting the pressure of the water jet. This optimization freed up time for other work operations. By exchanging the nozzle, the demolition robot was also used to clean the stone wall from deposits, soot and other impurities. After removing the concrete and cleaning the lining, the joints between the stone blocks were cut to the required depth of 80mm with a hand-held electric tool and rinsed with a water pressure washer at a pressure of up to 500 bar. The joints were subsequently filled with an expanding thixotropic mortar preventing water seepage. In total, grouting was carried out on an area of 8,116.60m<sup>2</sup>. The fallen parts of the tunnel lining were replaced with fibre-reinforced thixotropic

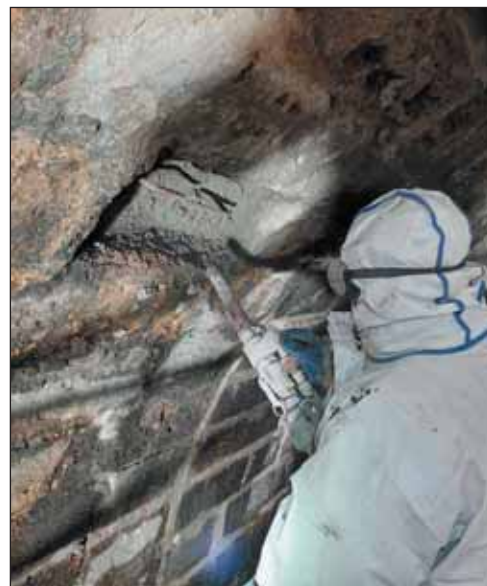
Obr. 5 Plombovanie vypadnutých kvádrov tunelového ostenia sanačnou hmotou  
Fig. 5 Sealing of fallen blocks of the tunnel lining with repair material

cement based material, which was applied to the surface of the lining with a shotcrete machine (Fig. 5). For better cohesion of the old masonry with the applied remedial material, steel spikes Ø 10mm chemically anchored into the masonry were installed.

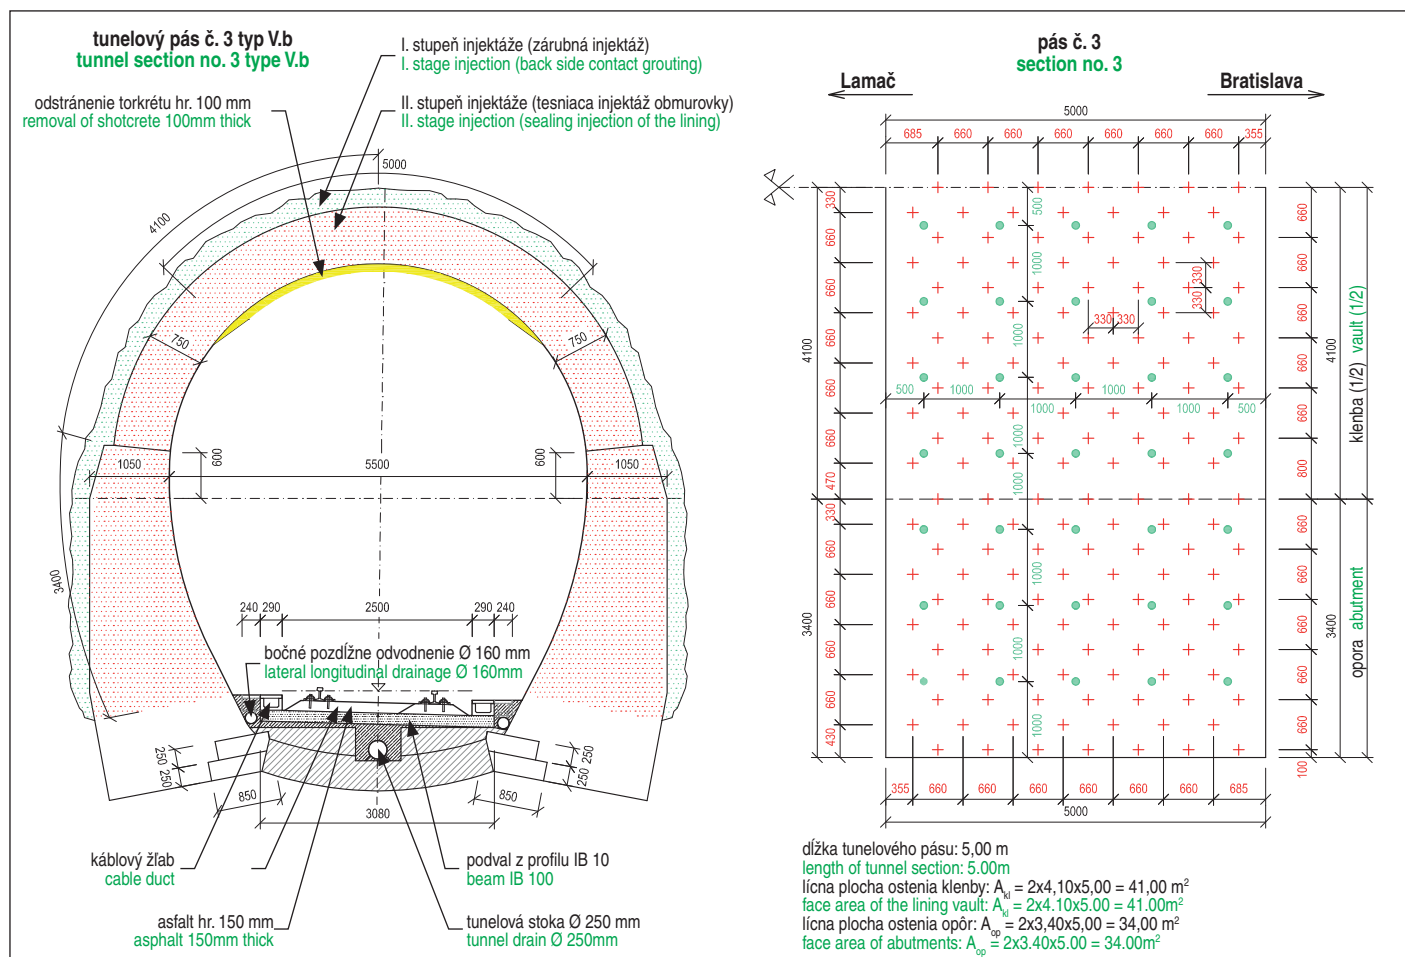
Obr. 6 Injektážna schéma pre tunelový blok č. 3  
Fig. 6 Injection scheme for tunnel section No. 3

The main rehabilitation operation in the tunnel was the pressure application of a two-stage sealing injection (Fig. 6) using

a two-component polyurethane, which was injected behind the lining through the injection obturators located in the joints of the stone masonry lining. The first stage was done by grouting of the rock immediately at contact with the backside of the tunnel lining. As the first stage boreholes had  $\varnothing 20$ mm and a length in the vault from 550 to 750mm, they could be drilled with a hand-held battery tool. Drilling  $\varnothing 32$ mm in the abutments reached a length of over 1000mm, therefore the Epiroc T15 drill rig was used. The grid of the drills was designed to be  $1.0 \times 1.0$ m, while their actual position depended on the position of the lining joints. The second stage of injection consisted of injecting the stone masonry lining of the tunnel to approximately  $2/3$  of its thickness. Hand-held cordless tools

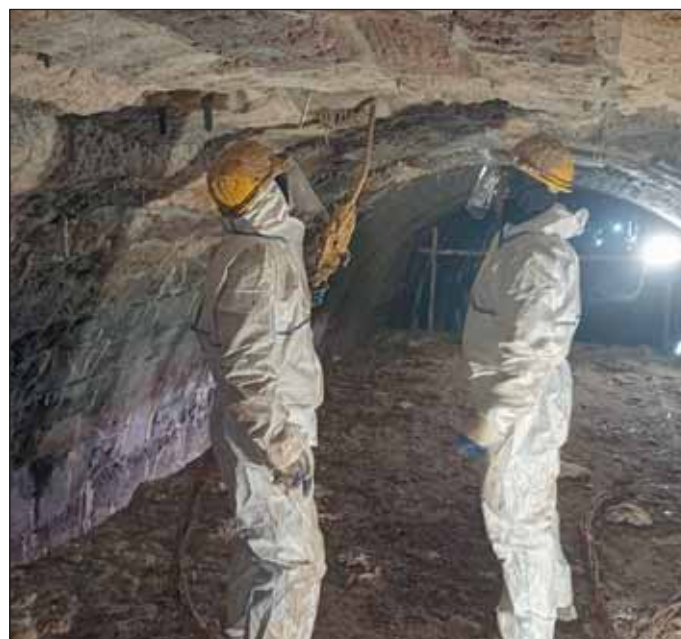
Obr. 7 Reinjektáž v klenbe tunela  
Fig. 7 Reinjection in the tunnel vault

were also used for these purposes, but the diameter of the holes in this case was only 14mm. The grid of boreholes was  $0.66 \times 0.66\text{m}$ . In the locations where additional seepage of groundwater appeared after the sealing injection, it was necessary to carry out reinjection (Fig. 7) in a checkerboard grid of  $0.33 \times 0.33\text{m}$  shifted from the injection holes of the second stage by 100mm. Approximately  $390\text{m}^3$  of injection mixture was consumed in the entire tunnel, including the portals.

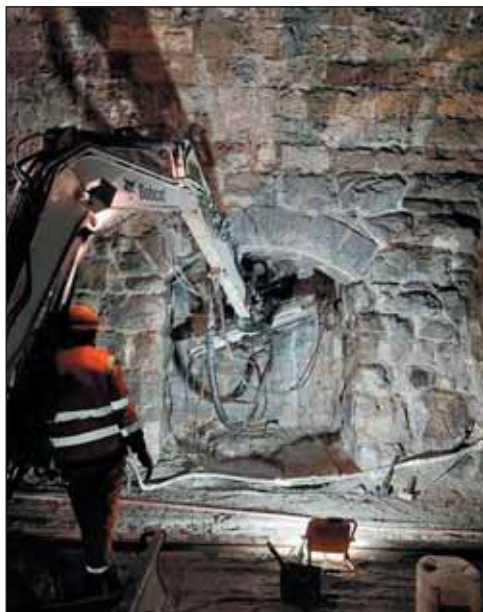
Obr. 8 Realizácia odvodňovacích vrtov v stiesnených pomeroch bezpečnostného výklenku

Fig. 8 Implementation of drainage drillholes in the tight space of the safety niche

hammered out with a hand-held electric tool, and then sub-horizontal drainage drillholes were drilled using a Bobcat tracked mini-excavator with a drill carriage (Fig. 8). Each niche contained 12 drainage drillholes  $\varnothing 76\text{mm}$  with a length of 6 to 12m, into which a perforated steel pipe  $\varnothing 60\text{mm}$  was installed.

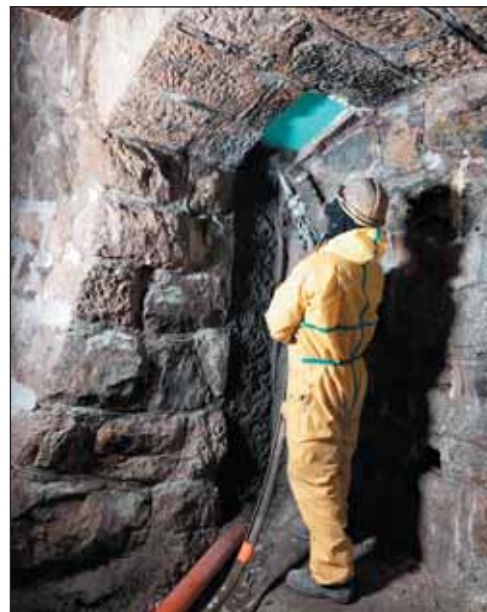
Obr. 9 Aplikácia striekaného betónu na zhotovené zvodnice

Fig. 9 Application of shotcrete on finished culverts

The culverts exited through a PVC pipe into the existing sewer shaft connected to the side drainage  $\varnothing 160\text{mm}$  in the tunnel walkway. Subsequently, the water pipes were covered with Styrofoam blocks covered with wire mesh and sprayed with a fiber-reinforced mortar to the thickness of 50mm (Fig. 9).

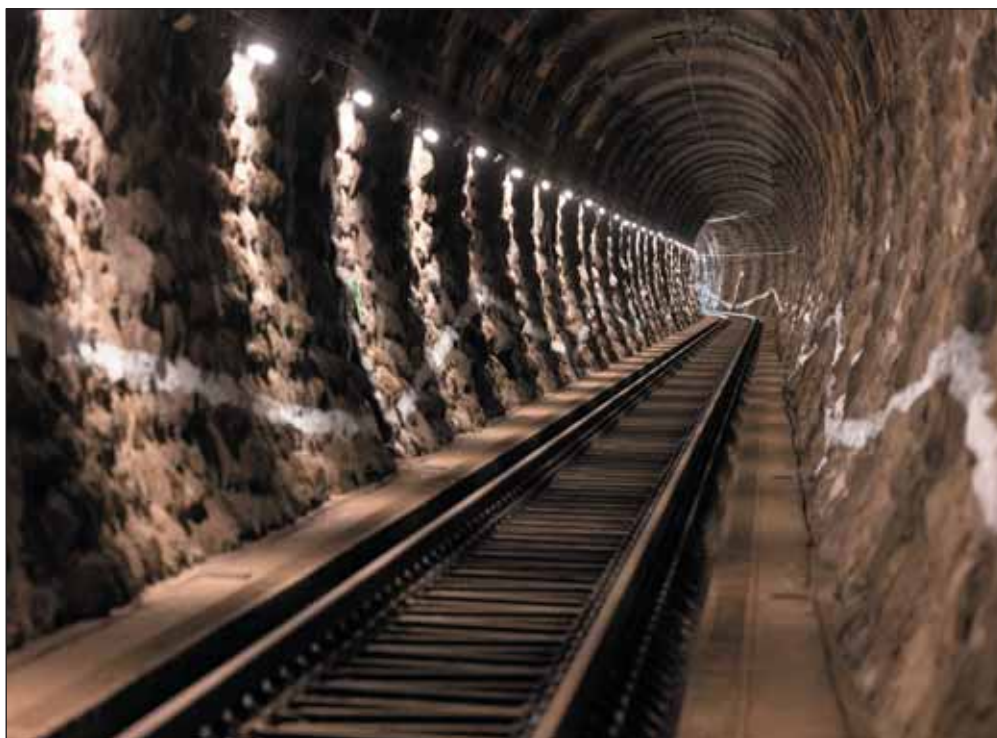
Obr. 10 Bratislavský tunel č. 2 po ukončených rekonštrukčných prácach

Fig. 10 Bratislava tunnel no. 2 after the completed reconstruction works

Additional activities in the tunnel included the restoration of white safety coatings on the tunnel abutments, installation of signs with the numbers of the tunnel blocks, signs indicating the direction and distance to the escape routes. The existing drainage system of the tunnel was also cleaned with a Man pressure-suction vehicle. Reconstruction works in tunnel no. 2 were successfully completed on 5/10/2023 and the tunnel was put into early use (Fig. 10).

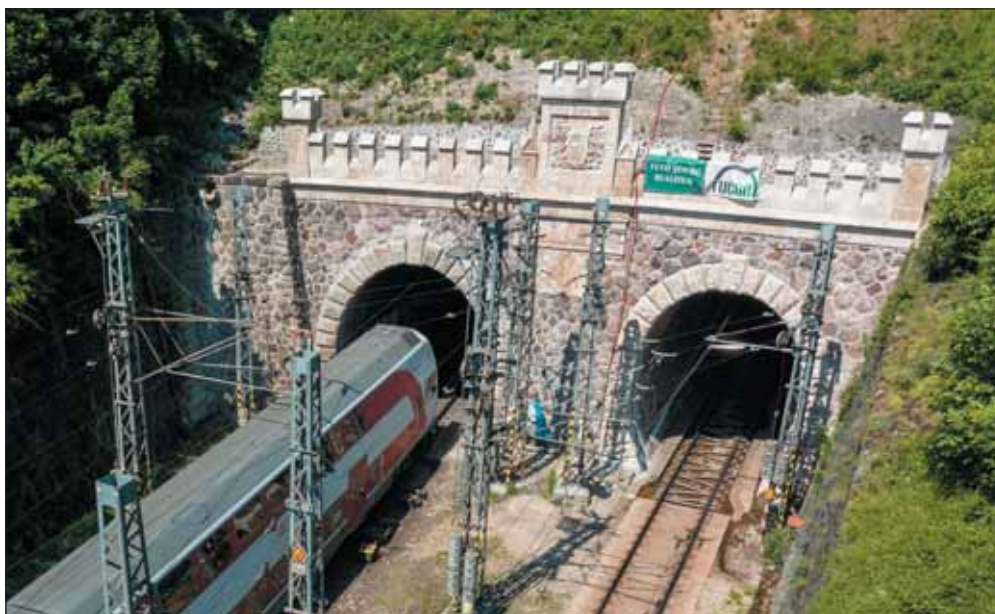
Obr. 11 Pohľad na zrekonštruovaný portál P2 od ŽST Bratislava hl. st.

Fig. 11 View of the reconstructed portal P2 from the Bratislava main railway station

The last N3 closure period of train service shutdown lasted 22 days, and the construction contractor requested the N3 closure period from the owner if during the first N1 closure period, the artistic and craft reconstruction of the portals P1 and P2 in the vicinity of the tunnel no. 1 would not be completed with regard to its scope and time requirement. This prediction turned out to be correct, as the work unfinished during the winter period had to be completed with the final treatment with a hydrophobic coating and organosilicates based surface penetration. View of the reconstructed portal P2 from the direction of the Bratislava main railway station is shown in Fig. 11.

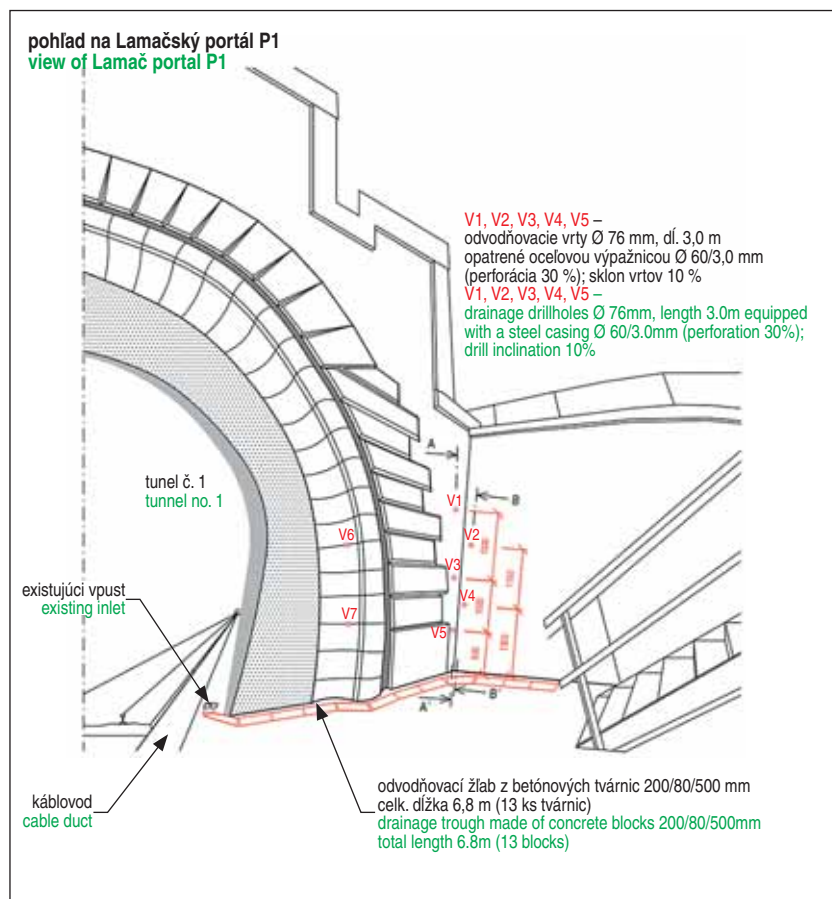
Obr. 12 Výkres priestorového usporiadania doplnkového riešenia v kúte portálu P1

Fig. 12 Drawing of the spatial arrangement of the additional solution in the corner of the portal P1

At the same time, restoration work could not be completed in the lower part of the P1 portal near the staircase wall due to wetting of the masonry, despite several sealing injections. Therefore, in agreement with the investor and the project designer, an additional technical solution was developed (Fig. 12) consisting of the realization of 7 drainage wells Ø 76mm, 3m long drilled from a new drainage channel made of trench drainage prefabricated blocks located at the foot of the portal. In order to prevent water from seeping through the porous material of the stone portal, a waterproofing elastic membrane was made around the mouth of the wells. The mentioned measure achieved the desired effect and the structure could be successfully handed over.

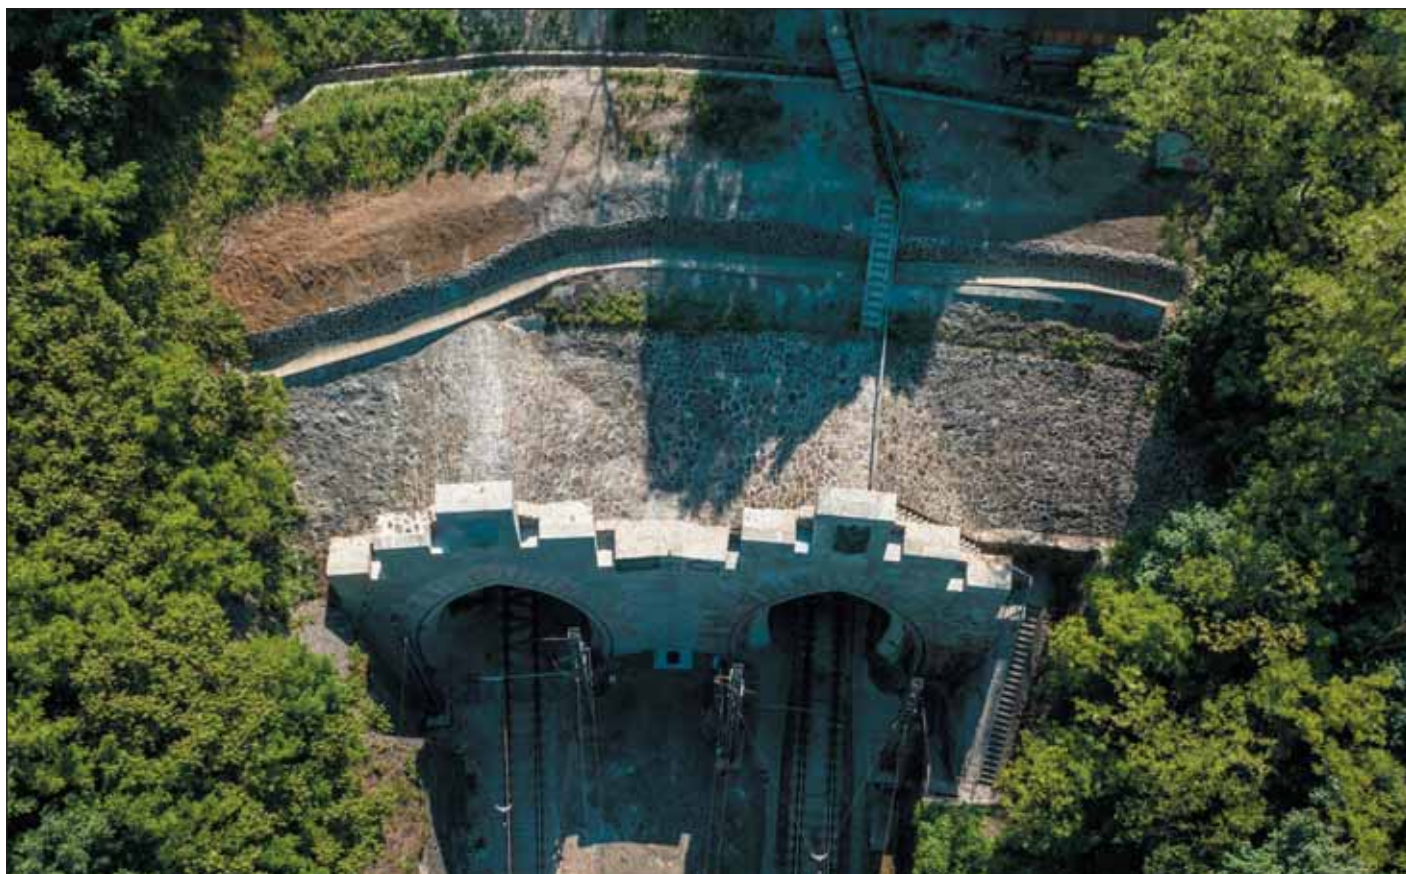
Obr. 13 Pohľad na celkovú situáciu portálu P1 od ŽST Lamač po ukončených prácach

Fig. 13 View of the overall situation of the P1 portal from the Lamač railway station after the completed works

In the areas above the portals and in the areas in front of the tunnels, several measures were implemented in parallel with the work in the tunnel, with the aim of eliminating water seepage from the surface of the terrain into the underground spaces of the tunnels. For this purpose, an inclined borehole Ø 93mm with a casing Ø 89mm was drilled, entering the trough above the portal P1 and coming through the portal structure into the newly built inspection shaft located in front of the portal face. The inspection shaft is also a common outlet for three newly drilled, fan-shaped, subhorizontal wells Ø 93mm, equipped with a perforated steel pipe Ø 89mm. They drain water from the lower tunnel space. The rehabilitation measures consisted of the construction of a drainage channel together with the adjacent stone pavement, the restoration of the original stone pavement, and the drainage ditch at the P1 portal (Fig. 13). At the P2 portal, the original stone ditch was restored by a new stone pavement.
